BROW HEAD

Mine Name: Brow Head

Project Prefix: BROW-

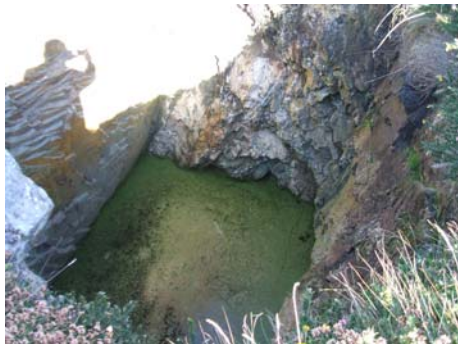
by a still-discernible sluice that runs west to two smaller walled areas that may have been processing ponds. Two shafts are visible on the site. The easternmost one, the main shaft (Fig. 1), is open to a depth of at least 5m below which it is filled with water (photo, left). The fence around it has been breached. The second shaft is also fenced and subsidence has taken place around it. There are three adits in the cliff-face, all of them open but accessible only by rope (O'Sullivan 2006).

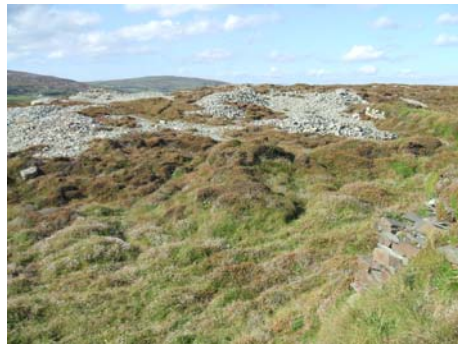
Solid waste is present both in two small heaps and as a thin layer spread on the surface close to the cliffs edge around the cobbled dressing floor (photo, right) (Table 1). The waste consists of coarse rock fragments scattered between growing bog. The small processing pool close to the waste heaps has a surface of fine pebbles and sand but beneath is a brown silt-sand-grade brown material that resembles processing waste. Table 1 gives the calculated areas and volumes for the waste heaps at Brow Head.

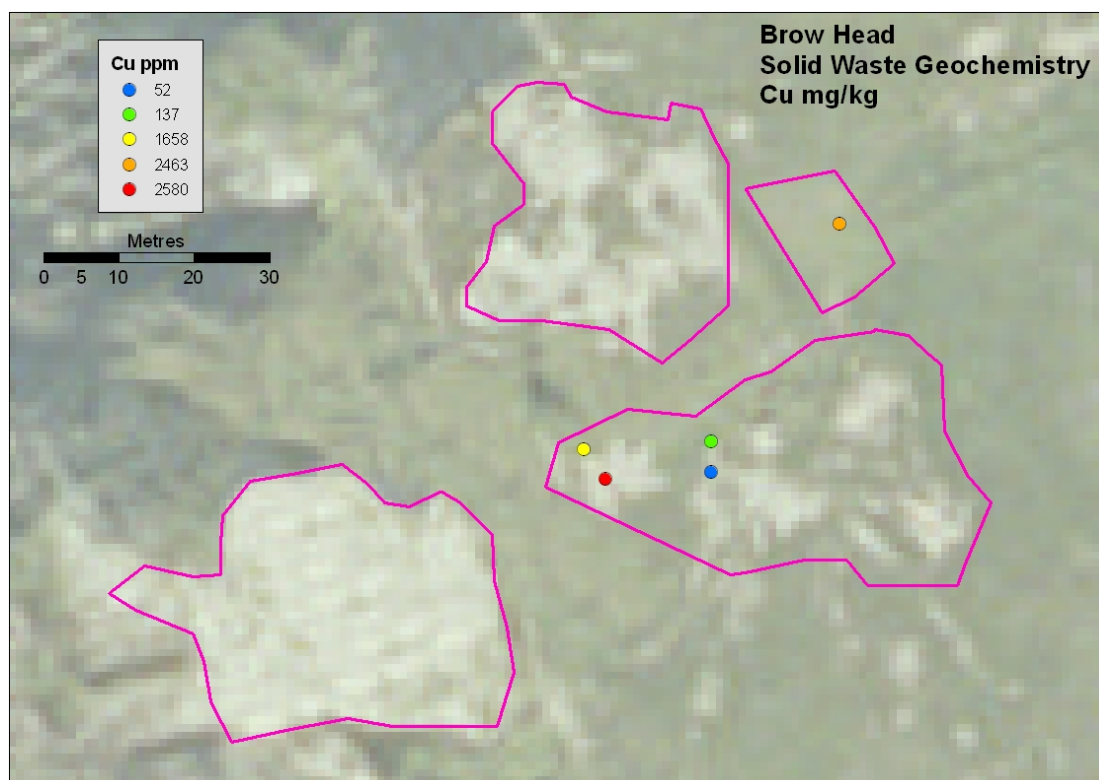
Fig X.2 Brow Head XRF Cu analysis

Five *in-situ* solid waste analyses were carried out at Brow Head, four on SP01 and one on the material forming the base of second processing pool (Fig. 2). The data for SP01 have been used to score both SP02 and SP03 for the HMS-IRC Site Scoring system. Copper concentrations ranged from 52 to 2580 mg/kg. Both Pb and As were detected at very low concentrations (≤ 65 ≤ 32 mg/kg, respectively). Among other elements of interest, only Ba (≤ 442 mg/kg) was present in significant concentrations.
